Name Of Dam: DIXIANA DAM
Location: WISE COUNTY, VIRGINIA
Inventory Number: VA. NO. 19505

PHASE I INSPECTION REPORT

NATIONAL DAM SAFETY PROGRAM

SCHNABEL ENGINEERING ASSOCIATES, P.C./
J. K. TIMMONS AND ASSOCIATES, INC.

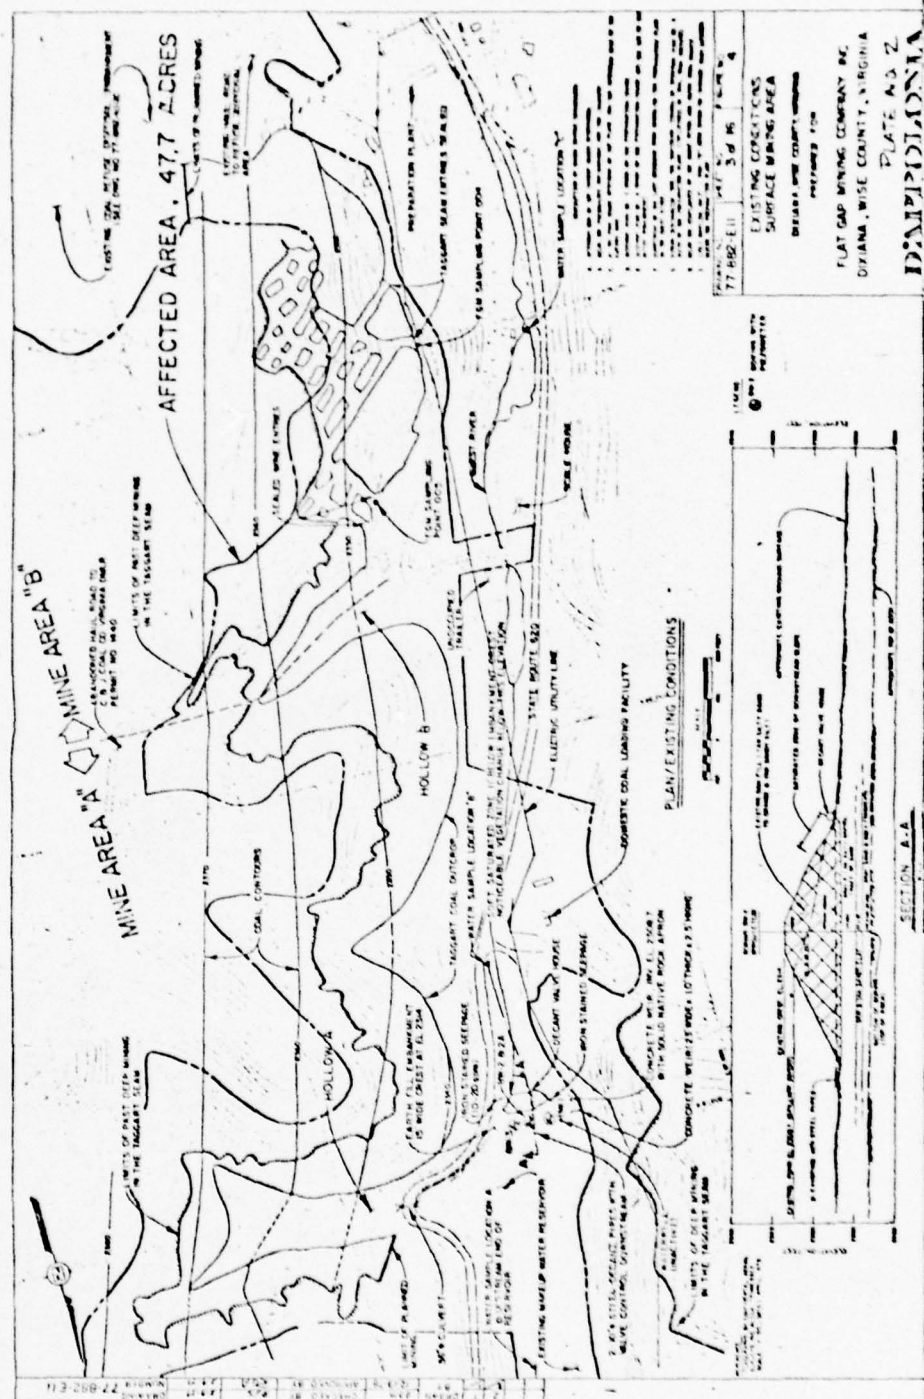
PROJECT NO.		SHEET NO.		FIGURE NO.	
77-892-E23		12 of 16		16	
MAKEUP WATER FACILITY					
SHEET 1 OF 2					
DIXIANA, WISE COUNTY, VIRGINIA					
PREPARED FOR					
FLAT GAP MINING COMPANY, INC.					
DIXIANA, WISE COUNTY, VIRGINIA					
PLATE NO. 3					
ID: A11101A

Stability analyses were performed by D'Appolonia for the proposed modifications and are summarized on Plate 3, Appendix I. Analyses were performed using the computer program STABL, developed by Purdue University for the Indiana State Highway Commission. STABL solves general slope stability problems by an adaptation of the Modified Bishop Method of Slices. A source listing of STABL was submitted to MSHA in August 1976 and is not included herein. The factors of safety and critical failure surfaces are shown on Plate 3, Appendix I. The stability analyses were performed for both static and pseudostatic (seismic) earthquake loading cases and minimum factors of safety of 1.54 and 1.43 were determined, respectively. Since the dam will be modified in the near future and stability analyses have been performed for this modification, no additional studies are recommended to evaluate the stability of the existing dam.
